**Subject: Jackson County Landfill  
Jackson, Ohio  
EPA ID No. OHD 980 993 554  
Focused Site Inspection Prioritization  
Contract No. 68-W8-0084, Work Assignment No. 35-5JZZ**

**FOCUSED SITE INSPECTION PRIORITIZATION  
SITE EVALUATION REPORT**

**JACKSON COUNTY LANDFILL  
1841 SMITH BRIDGE ROAD  
JACKSON, OHIO**

**EPA ID NO. OHD 980 993 554**

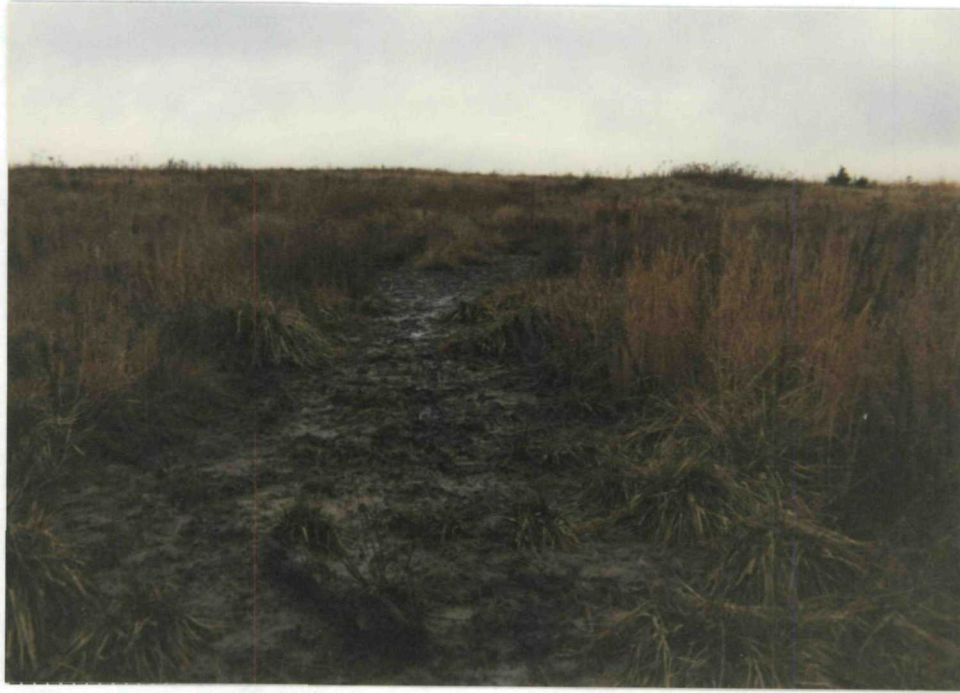
Photograph No. 1

During the site reconnaissance, PRC noted numerous leachate seeps on the east and west-northwest slopes of the landfill (see Photographs No. 1 through 6). An erosional channel runs along the east and north sides of the landfill, and in places the topsoil has been eroded to the bedrock surface (see Photographs No. 7 through 9). PRC also noted other erosional features on the landfill slopes (see Photographs No. 4, 10, and 11).

Description: This photograph shows a leachate seep on the east slope of the landfill. Note the dead vegetation in the seep area.

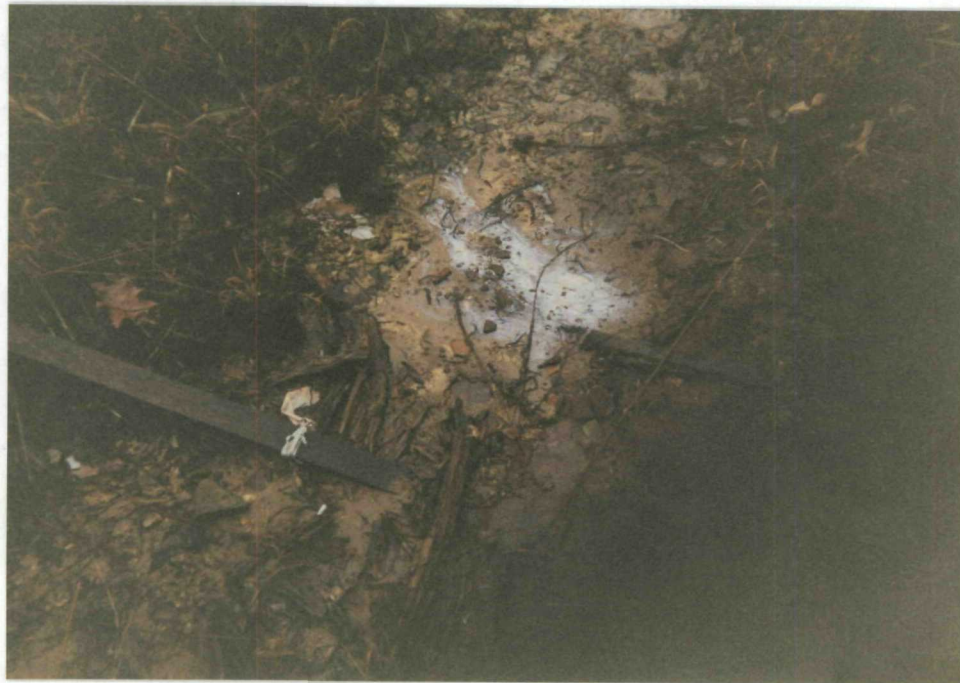
Photograph No. 2

Description: An oily sheen was observed on the landfill's north slope.

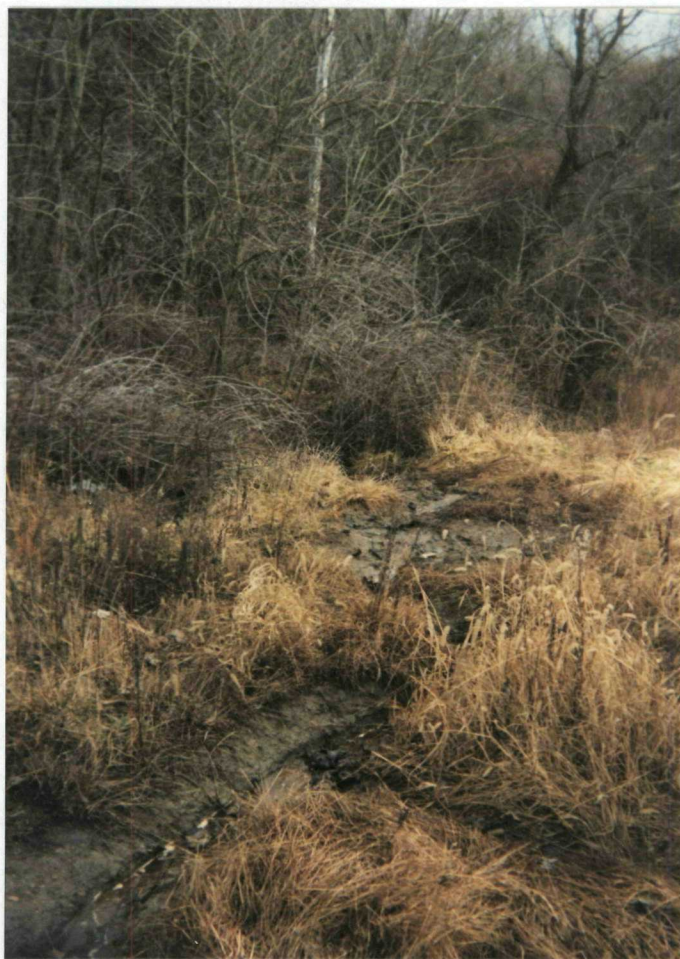
Photograph No. 4

A release of nickel from the JCL site to Little Salt Creek has been documented based on analytical results. As stated in Section 5.2, soil and sediment samples collected during FSIP activities contained elevated concentrations of nickel (EPA 1995a and 1995c). Several leachate seeps have also been identified on the north and northwest slopes of the landfill, but they have not been observed flowing directly into Little Salt Creek (see Photographs No. 4, 5, 9, and 10).

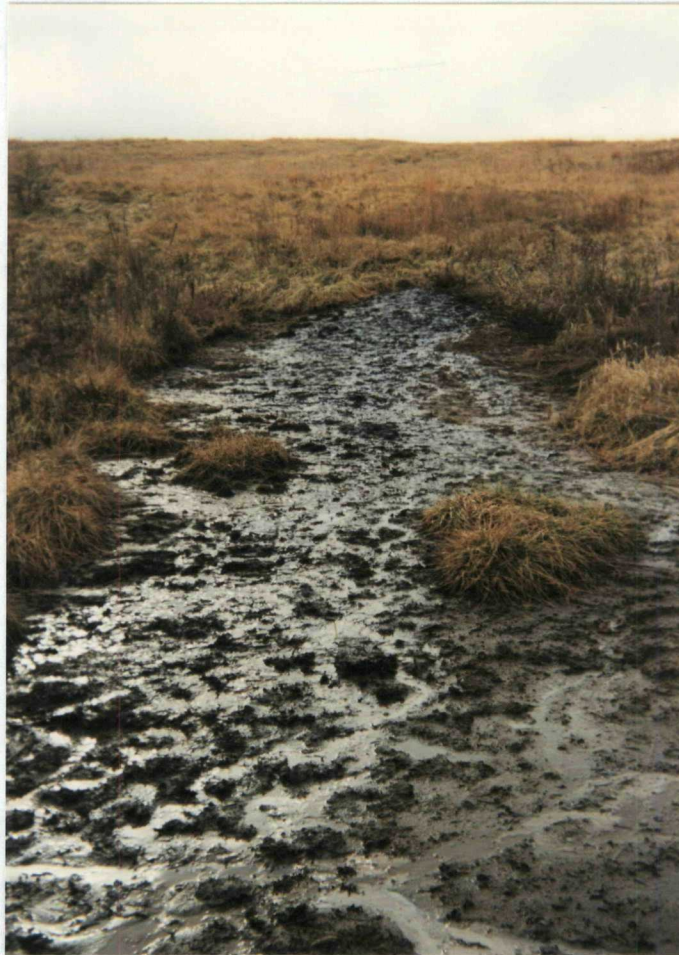
Photograph No. 5

Description: Test pitting activities caused this large leachate seep to form on the northwest slope of the landfill.

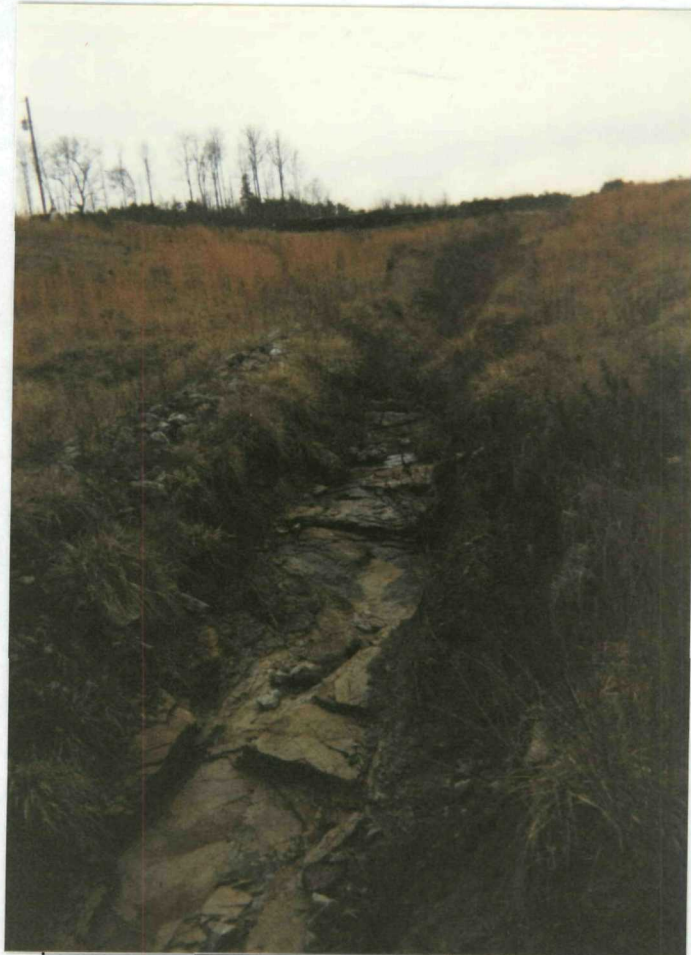
Photograph No. 8

Description: The drainage channel shown in Photograph No. 7 exposes bedrock further downstream. Note the rip-rap on the left side of the channel.

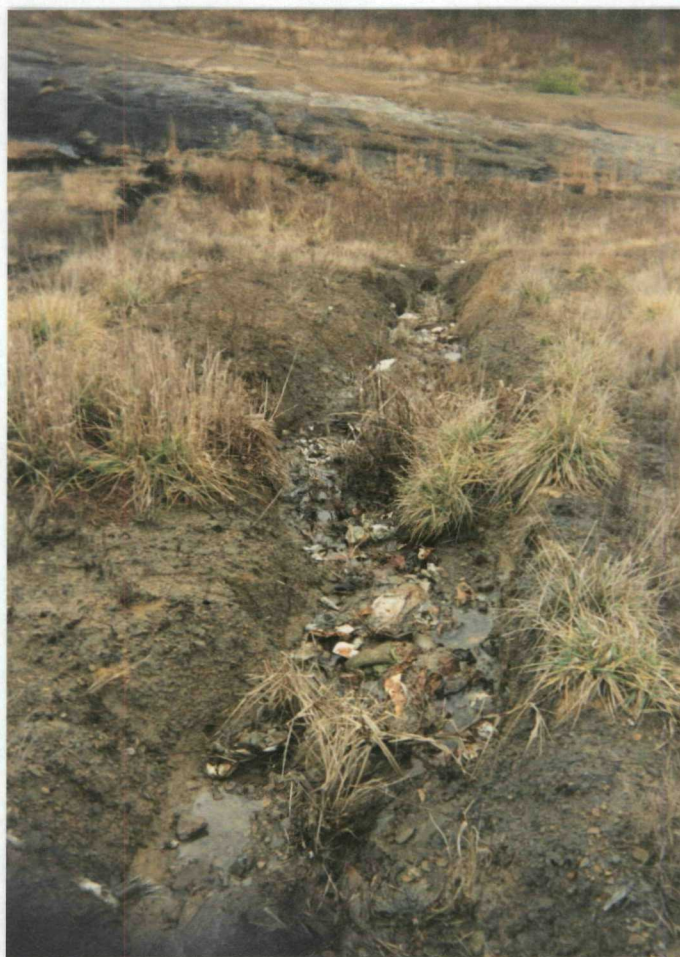
Photograph No. 11

PRC observed exposed rubbish in erosional channels on the southeast slope of the landfill (see Photographs No. 11 and 12). Bubbles were noted in some leachate seep areas, apparently indicating methane or other gas seepage (see Photograph No. 13). Slight odors from leachate seeps were detected during the site reconnaissance. The original borrow area is presently used for junked vehicles, discarded equipment, and refuse (see Photographs No. 14 and 15). Although the north portion of the landfill cap appears to be intact, the south portion of the cap is exposed and lacks vegetation (see Photographs No. 16 and 17, respectively). PRC observed an engineered surface water

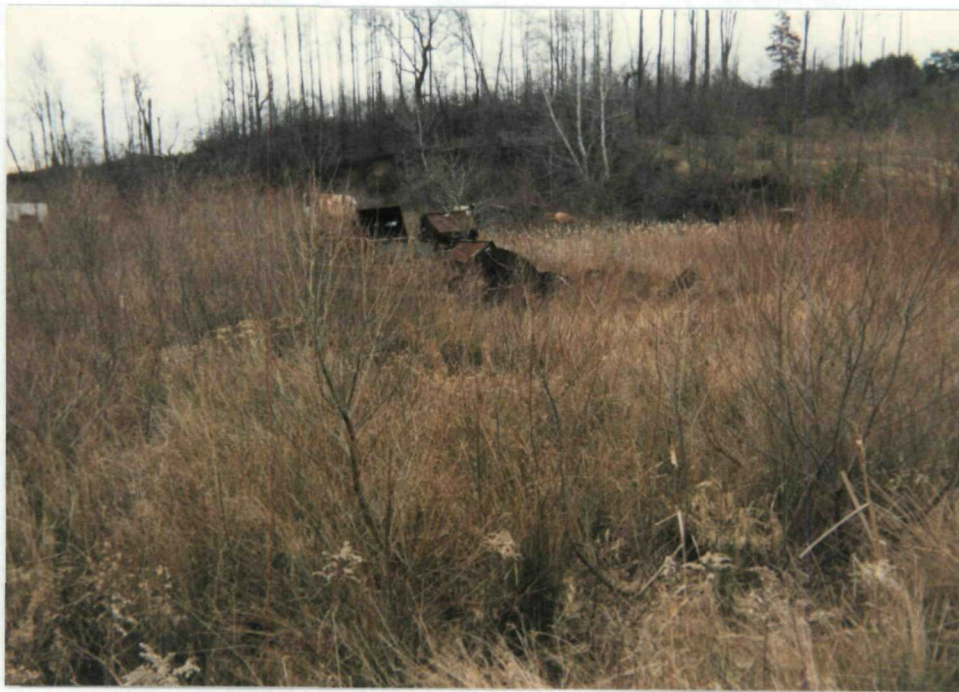
Photograph No. 15

Description: This area is located west of the erosional channel shown in Photograph No. 7. During the site reconnaissance, refuse was observed in this area, which was originally a borrow area.

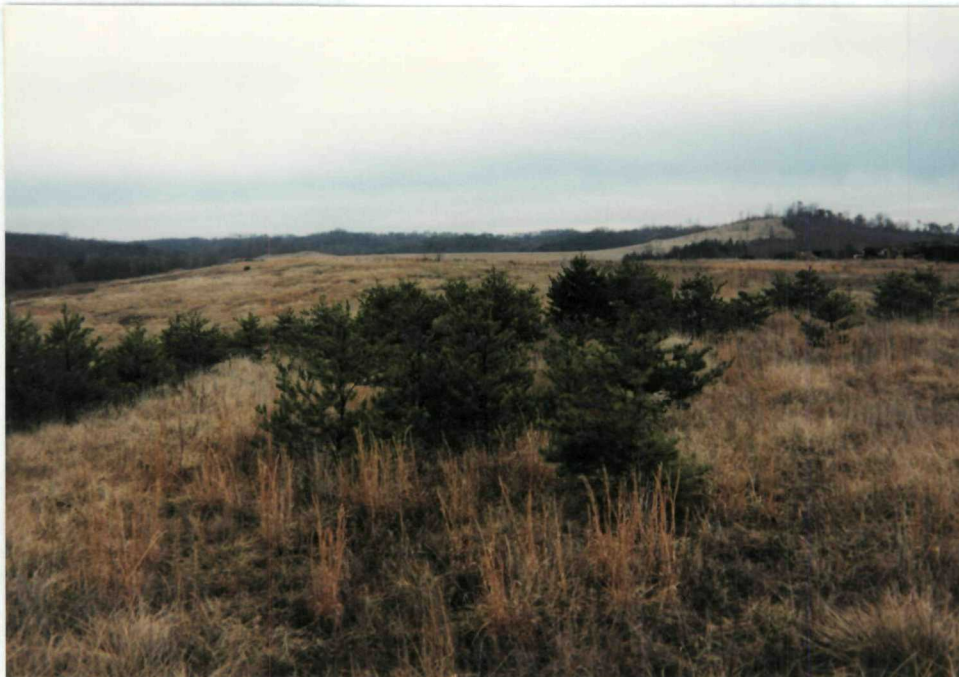
Photograph No. 16

Description: This photograph shows the north portion of the landfill cap.

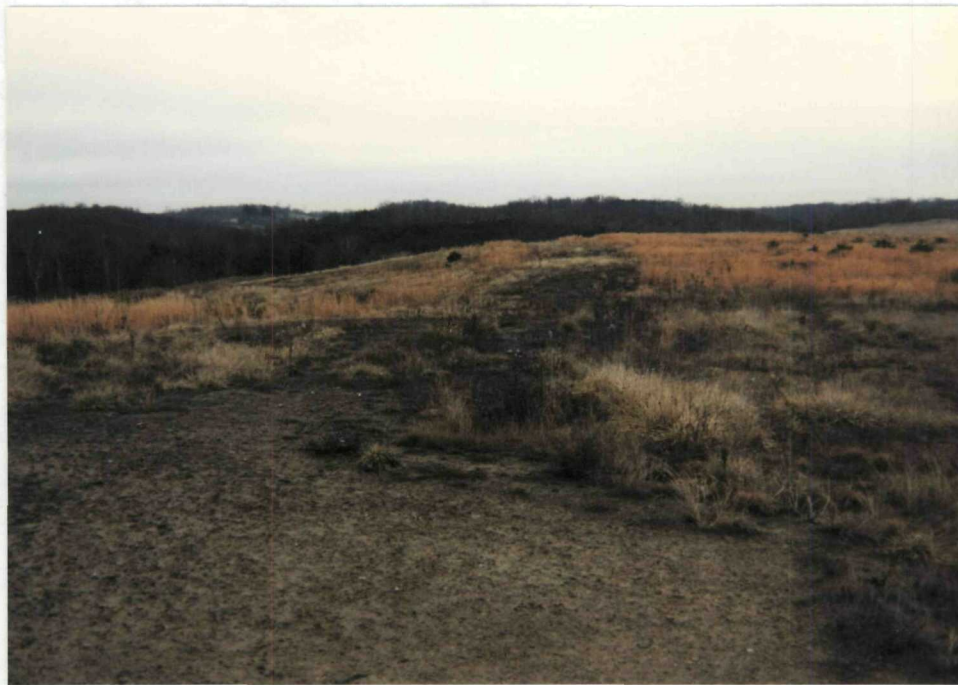
Photograph No. 17

Description: This photograph shows the south portion of the landfill cap. Note the shaly, nonvegetated cover.

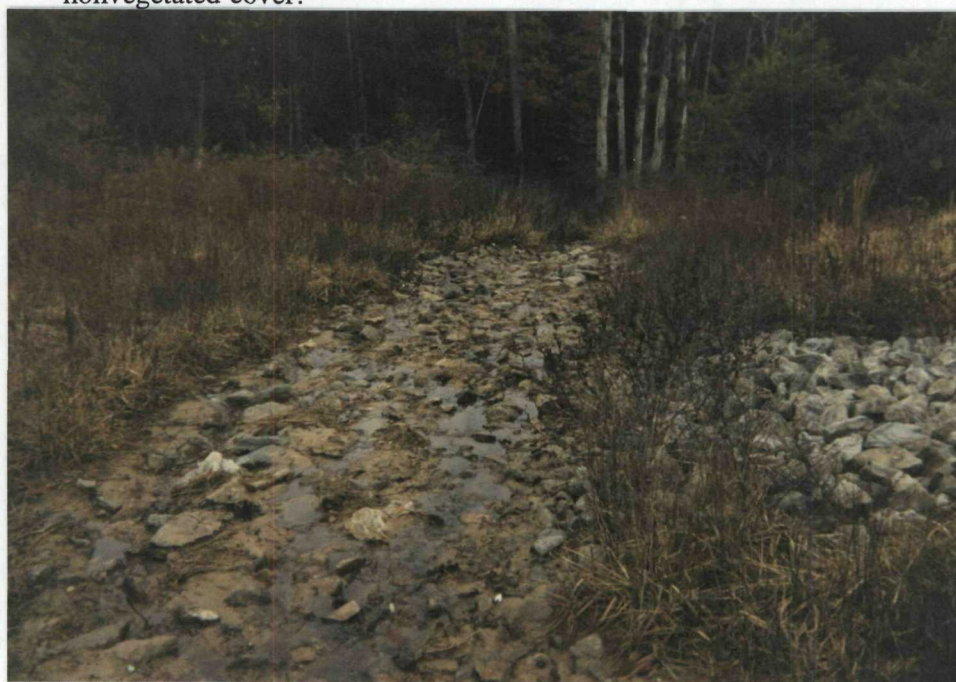
Photograph No. 18

During capping activities in 1987, JCL constructed a surface water runoff pathway on the north portion of the landfill cap (see Photograph No. 18). The pathway, which is made of coarse stone, allows surface water on the landfill cap to drain down the landfill slope and flow into the drainage channel on the landfill's north slope. During the FSIP sampling visit, PRC observed a ravine on the landfill's west slope that runs from the landfill to Little Salt Creek.

Description: An engineered drainage channel is present on the north portion of the landfill cap.

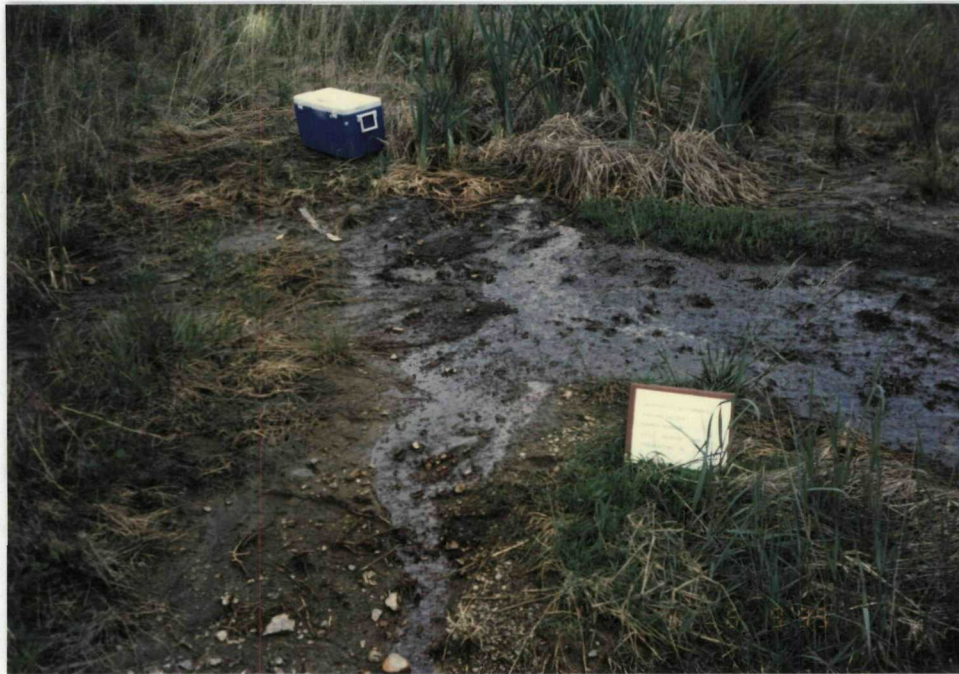
Photograph No. 27  
 Orientation: North  
 Description: This photograph shows sampling location SS-2.

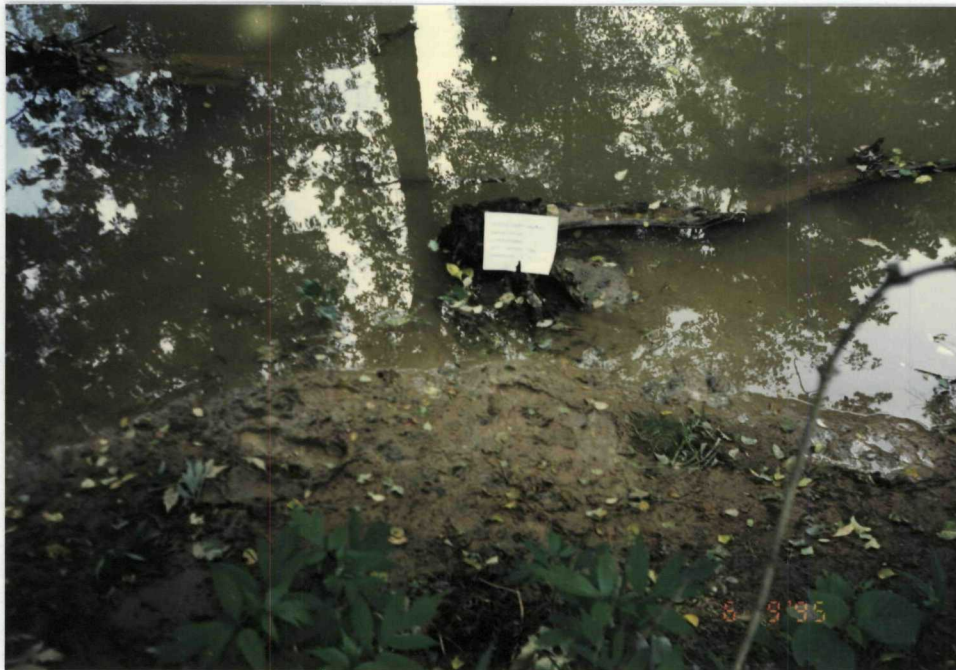
Photograph No. 28  
 Orientation: Downward  
 Description: This photograph shows sampling location SD-3.
